Technical Evaluation of the Gold King Mine Incident

San Juan County, Colorado

U.S. Department of the Interior
Bureau of Reclamation
Technical Service Center
Denver, Colorado

October 2015

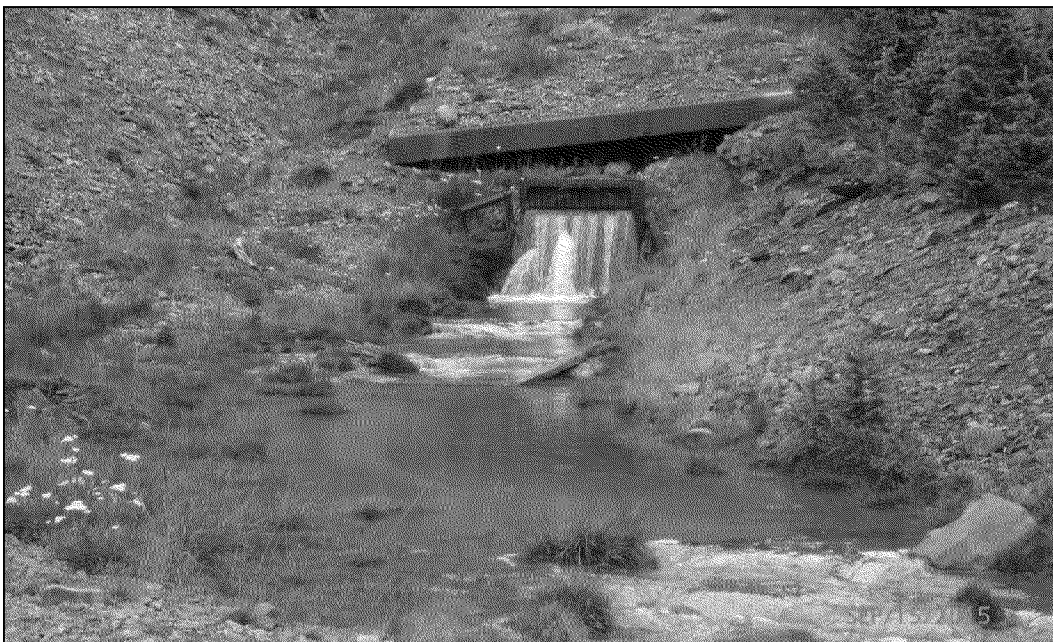
Figure 12.—Photograph taken on September 15, 2015, of drainage from the Silver Ledge Mine, which is located south of the Gold King Mine.

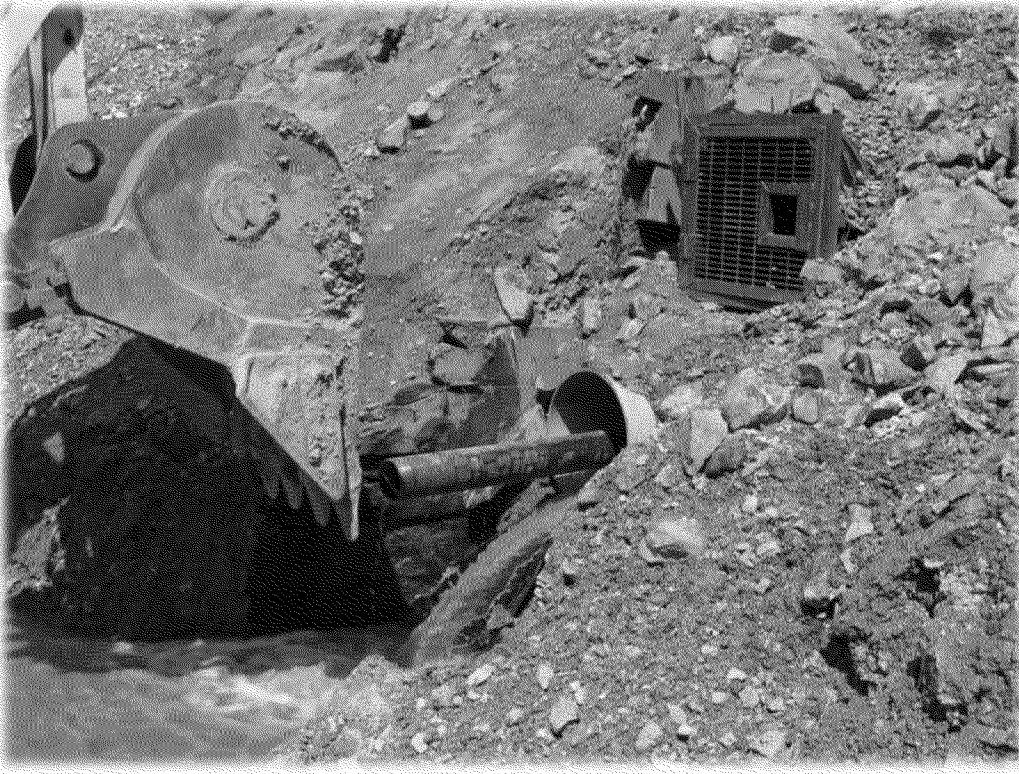
Gold King Level 7 Old Portal with well-point installed through the drain pipe. This portal may be re-opened in a future project to help stabilize the mine drainage and prevent future increases in mine pool head.

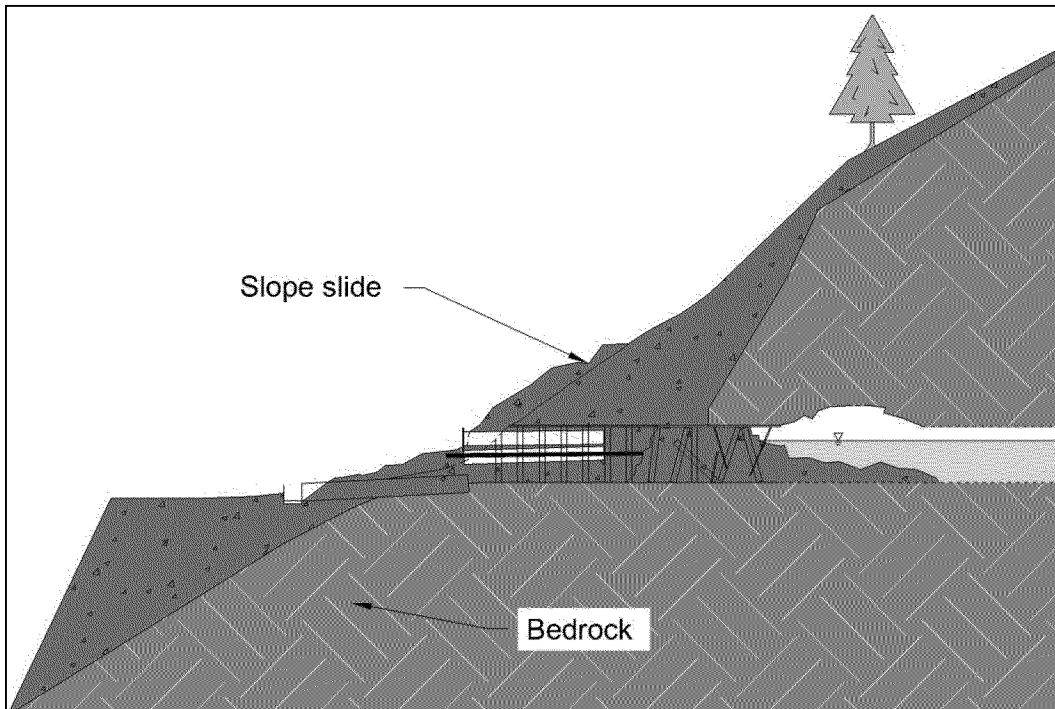
Figure 23.—Cross-section showing the condition of the Gold King Mine Level 7 New Adit in 2014 (water level as assumed by EPA and DRMS), more rock and soil had come down off the slope and were partially blocking the drain, which indicates a lack of maintenance (not to scale).

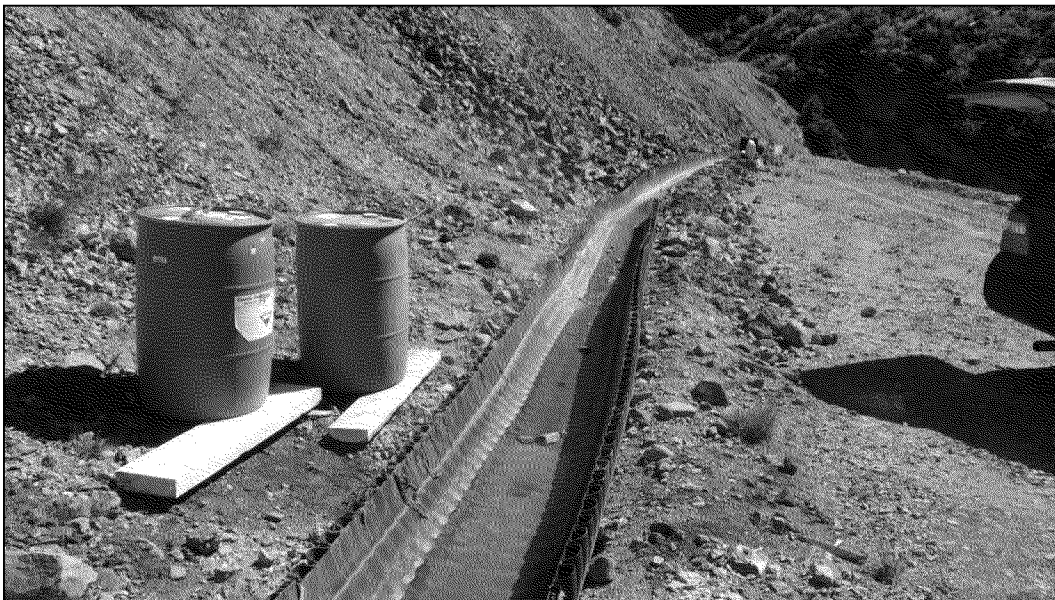
Figure 24.—Photograph showing seepage flow in the half-pipe channel at the Gold King Mine Level 7 New Adit area on September 11, 2014. Flow of approximately 12.6 gpm was recorded (photograph from EPA project files).

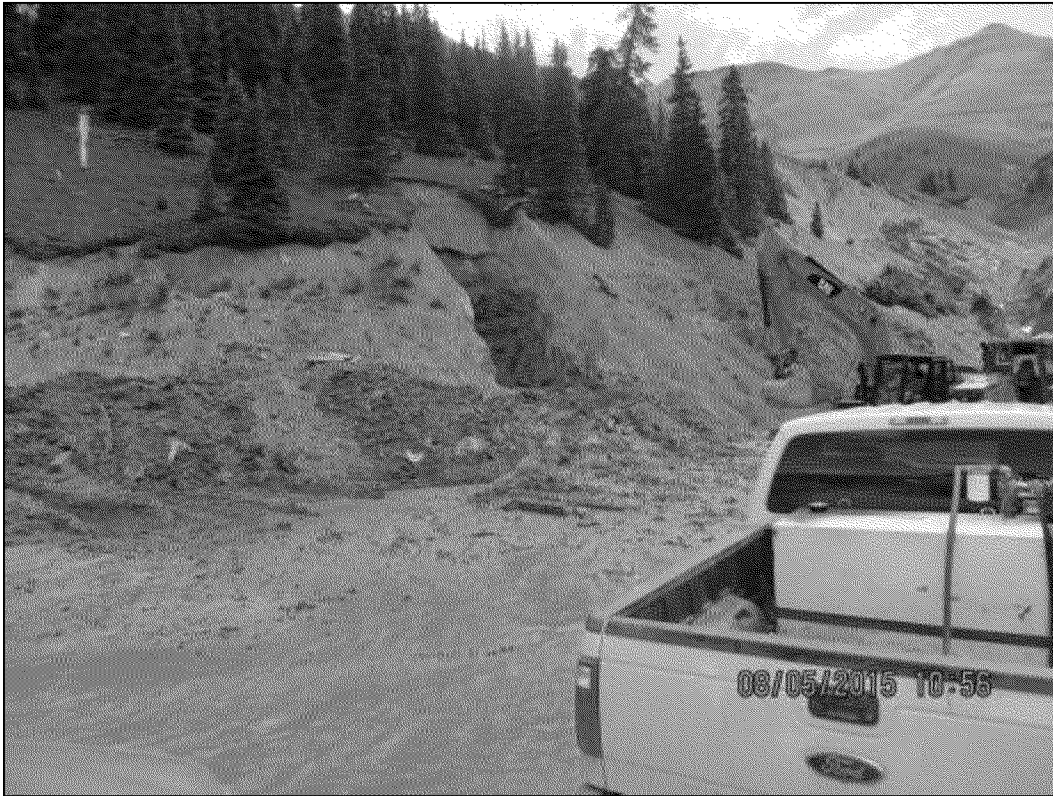
Figure 53.—Photograph showing the blowout at 10:56 a.m. on August 5, 2015 (photograph from EPA project files).

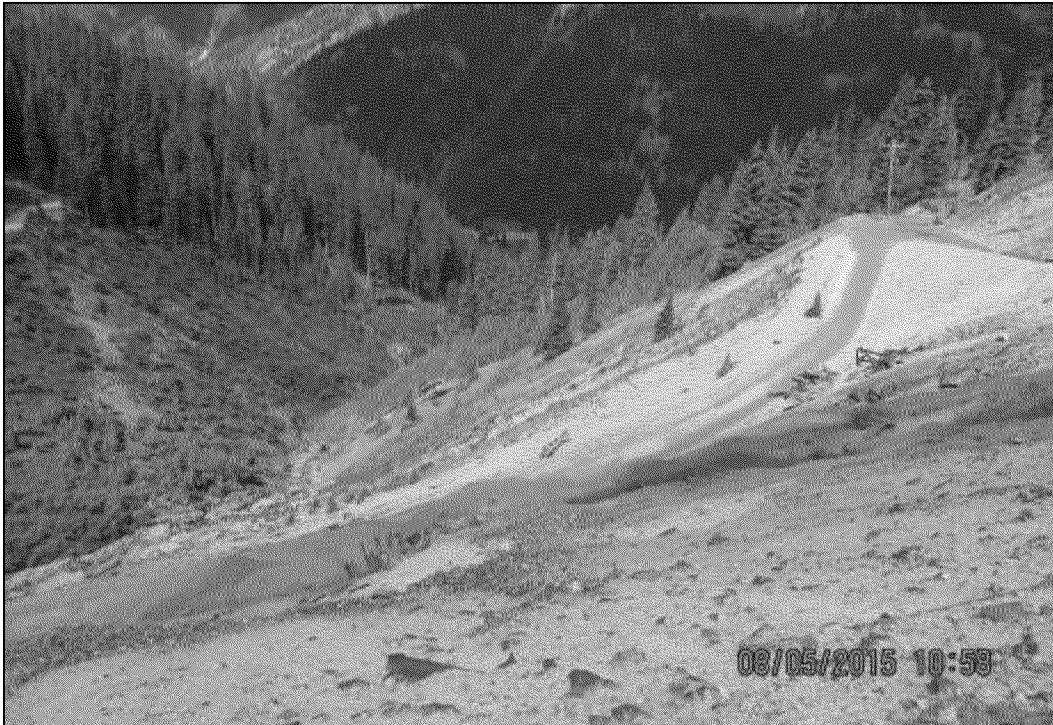
Figure 57.—Photograph showing a portion of the mine water flowing down the access road at 10:58 a.m. on August 5, 2015 (photograph from EPA project files).

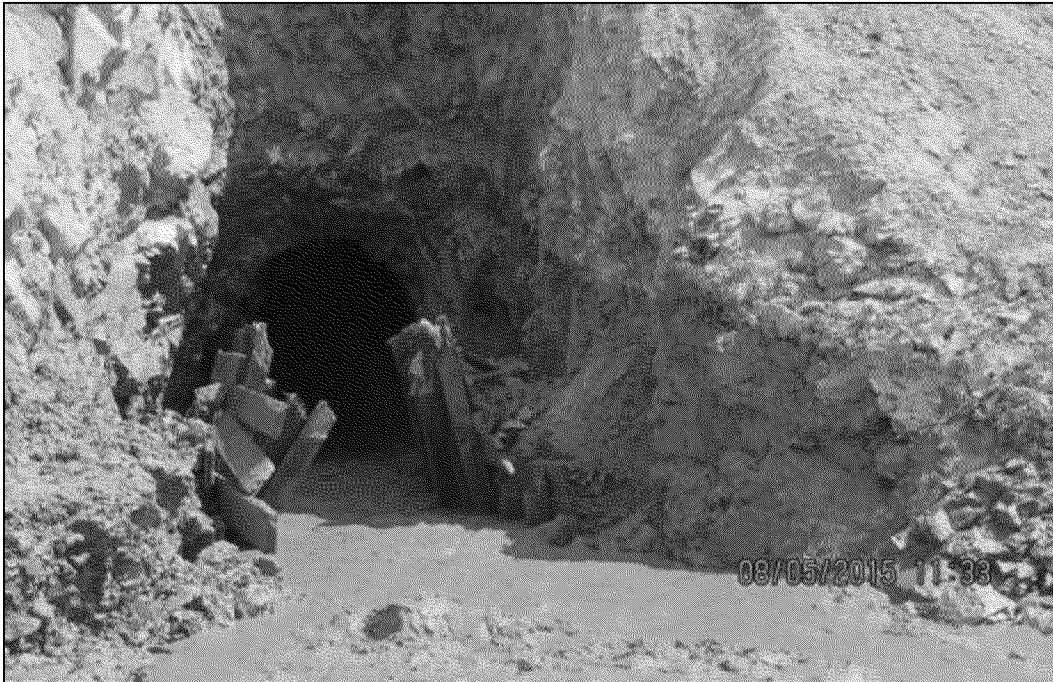
Figure 59.—Photograph showing the condition of the adit at 11:33 a.m., August 5, 2015; the peak flow of the uncontrolled release had passed and the flow rate was decreasing (photograph from EPA project files).

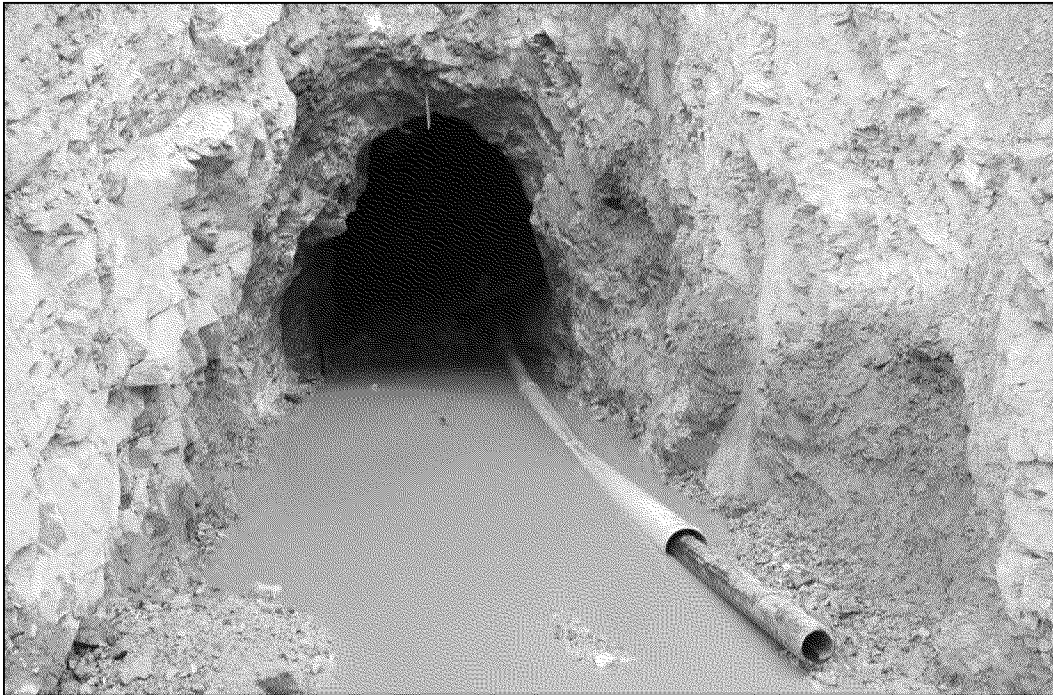
Figure 63.—Photograph showing the adit on August 16, 2015, with an 80-ft long (four 20-foot segments) turquoise-colored 24-inch outside-diameter drain pipe inserted into the adit opening. An 8-inch inside-diameter black HDPE pipe has been inserted into the 24-inch diameter pipe.

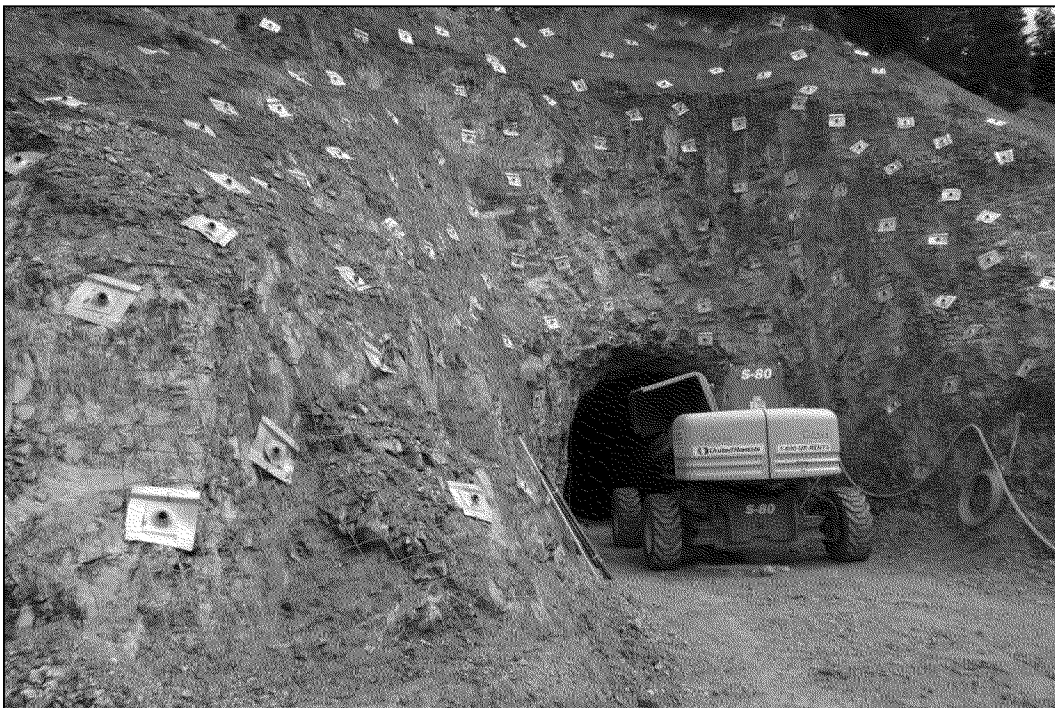
Figure 65.—Photograph taken on September 15, 2015, showing the installation of wire mesh and rock bolts to stabilize the outside of the mine opening.
